**2014 Annual Groundwater
Monitoring Report**

Palermo Wellfield Superfund Site
Tumwater, Washington

**Washington State Department of
Transportation**

February 24, 2017

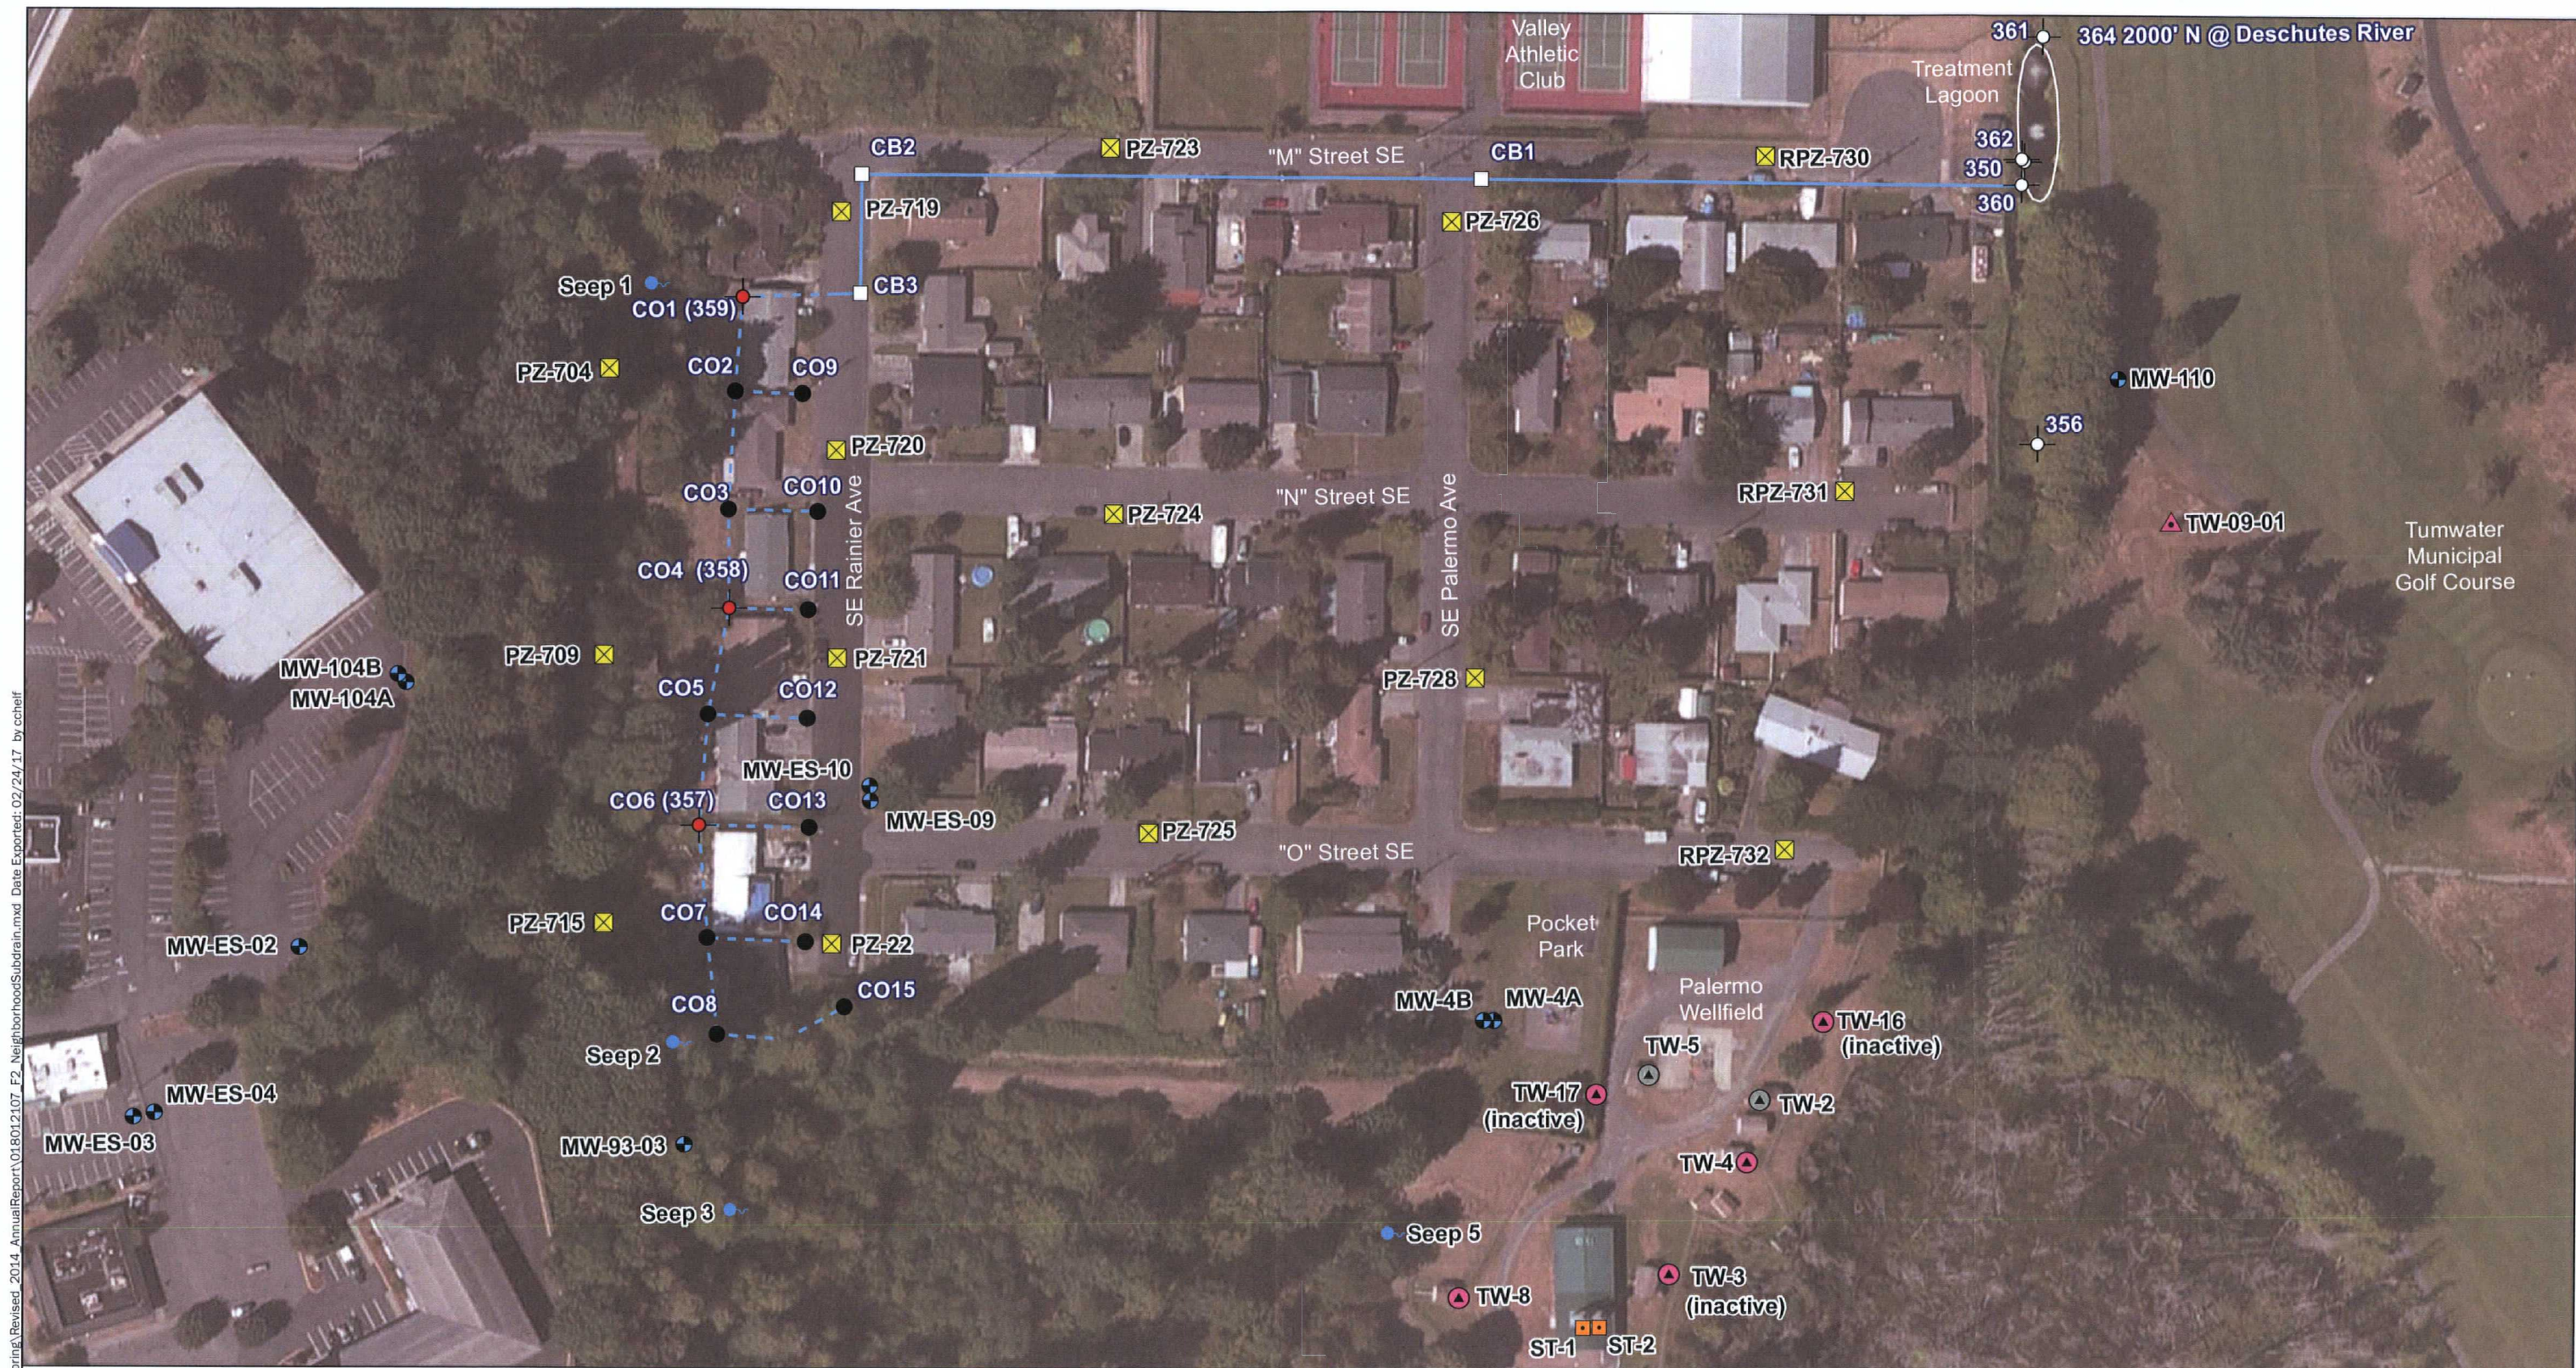
Site Plan	
Palermo Wellfield Superfund Site	
	Figure 1

1. The locations of all features shown are approximate.
2. This drawing is for information purposes. It is intended to assist in showing features discussed in an attached document. GeoEngineers, Inc. cannot guarantee the accuracy and content of electronic files. The master file is stored by GeoEngineers, Inc. and will serve as the official record of this communication.
3. TW-3, TW-16, and TW-17 are installed but not operating.

This annual report was prepared to summarize Spring (April) and Summer (August) 2014 semiannual groundwater monitoring results at the Palermo Wellfield Superfund Site (Site), U.S. Environmental Protection Agency (EPA) ID: WA 0000026534, located in Tumwater, Washington (Figure 1). This annual groundwater monitoring report was prepared for the Washington State Department of Transportation (WSDOT) in accordance with the requirements described in the Administrative Settlement Agreement and Order on Consent for Response Actions (ASAOC) Statement of Work (SOW), CERCLA Docket 10-2012-0149, entered into by EPA and WSDOT, effective July 6, 2012 (EPA, 2012).

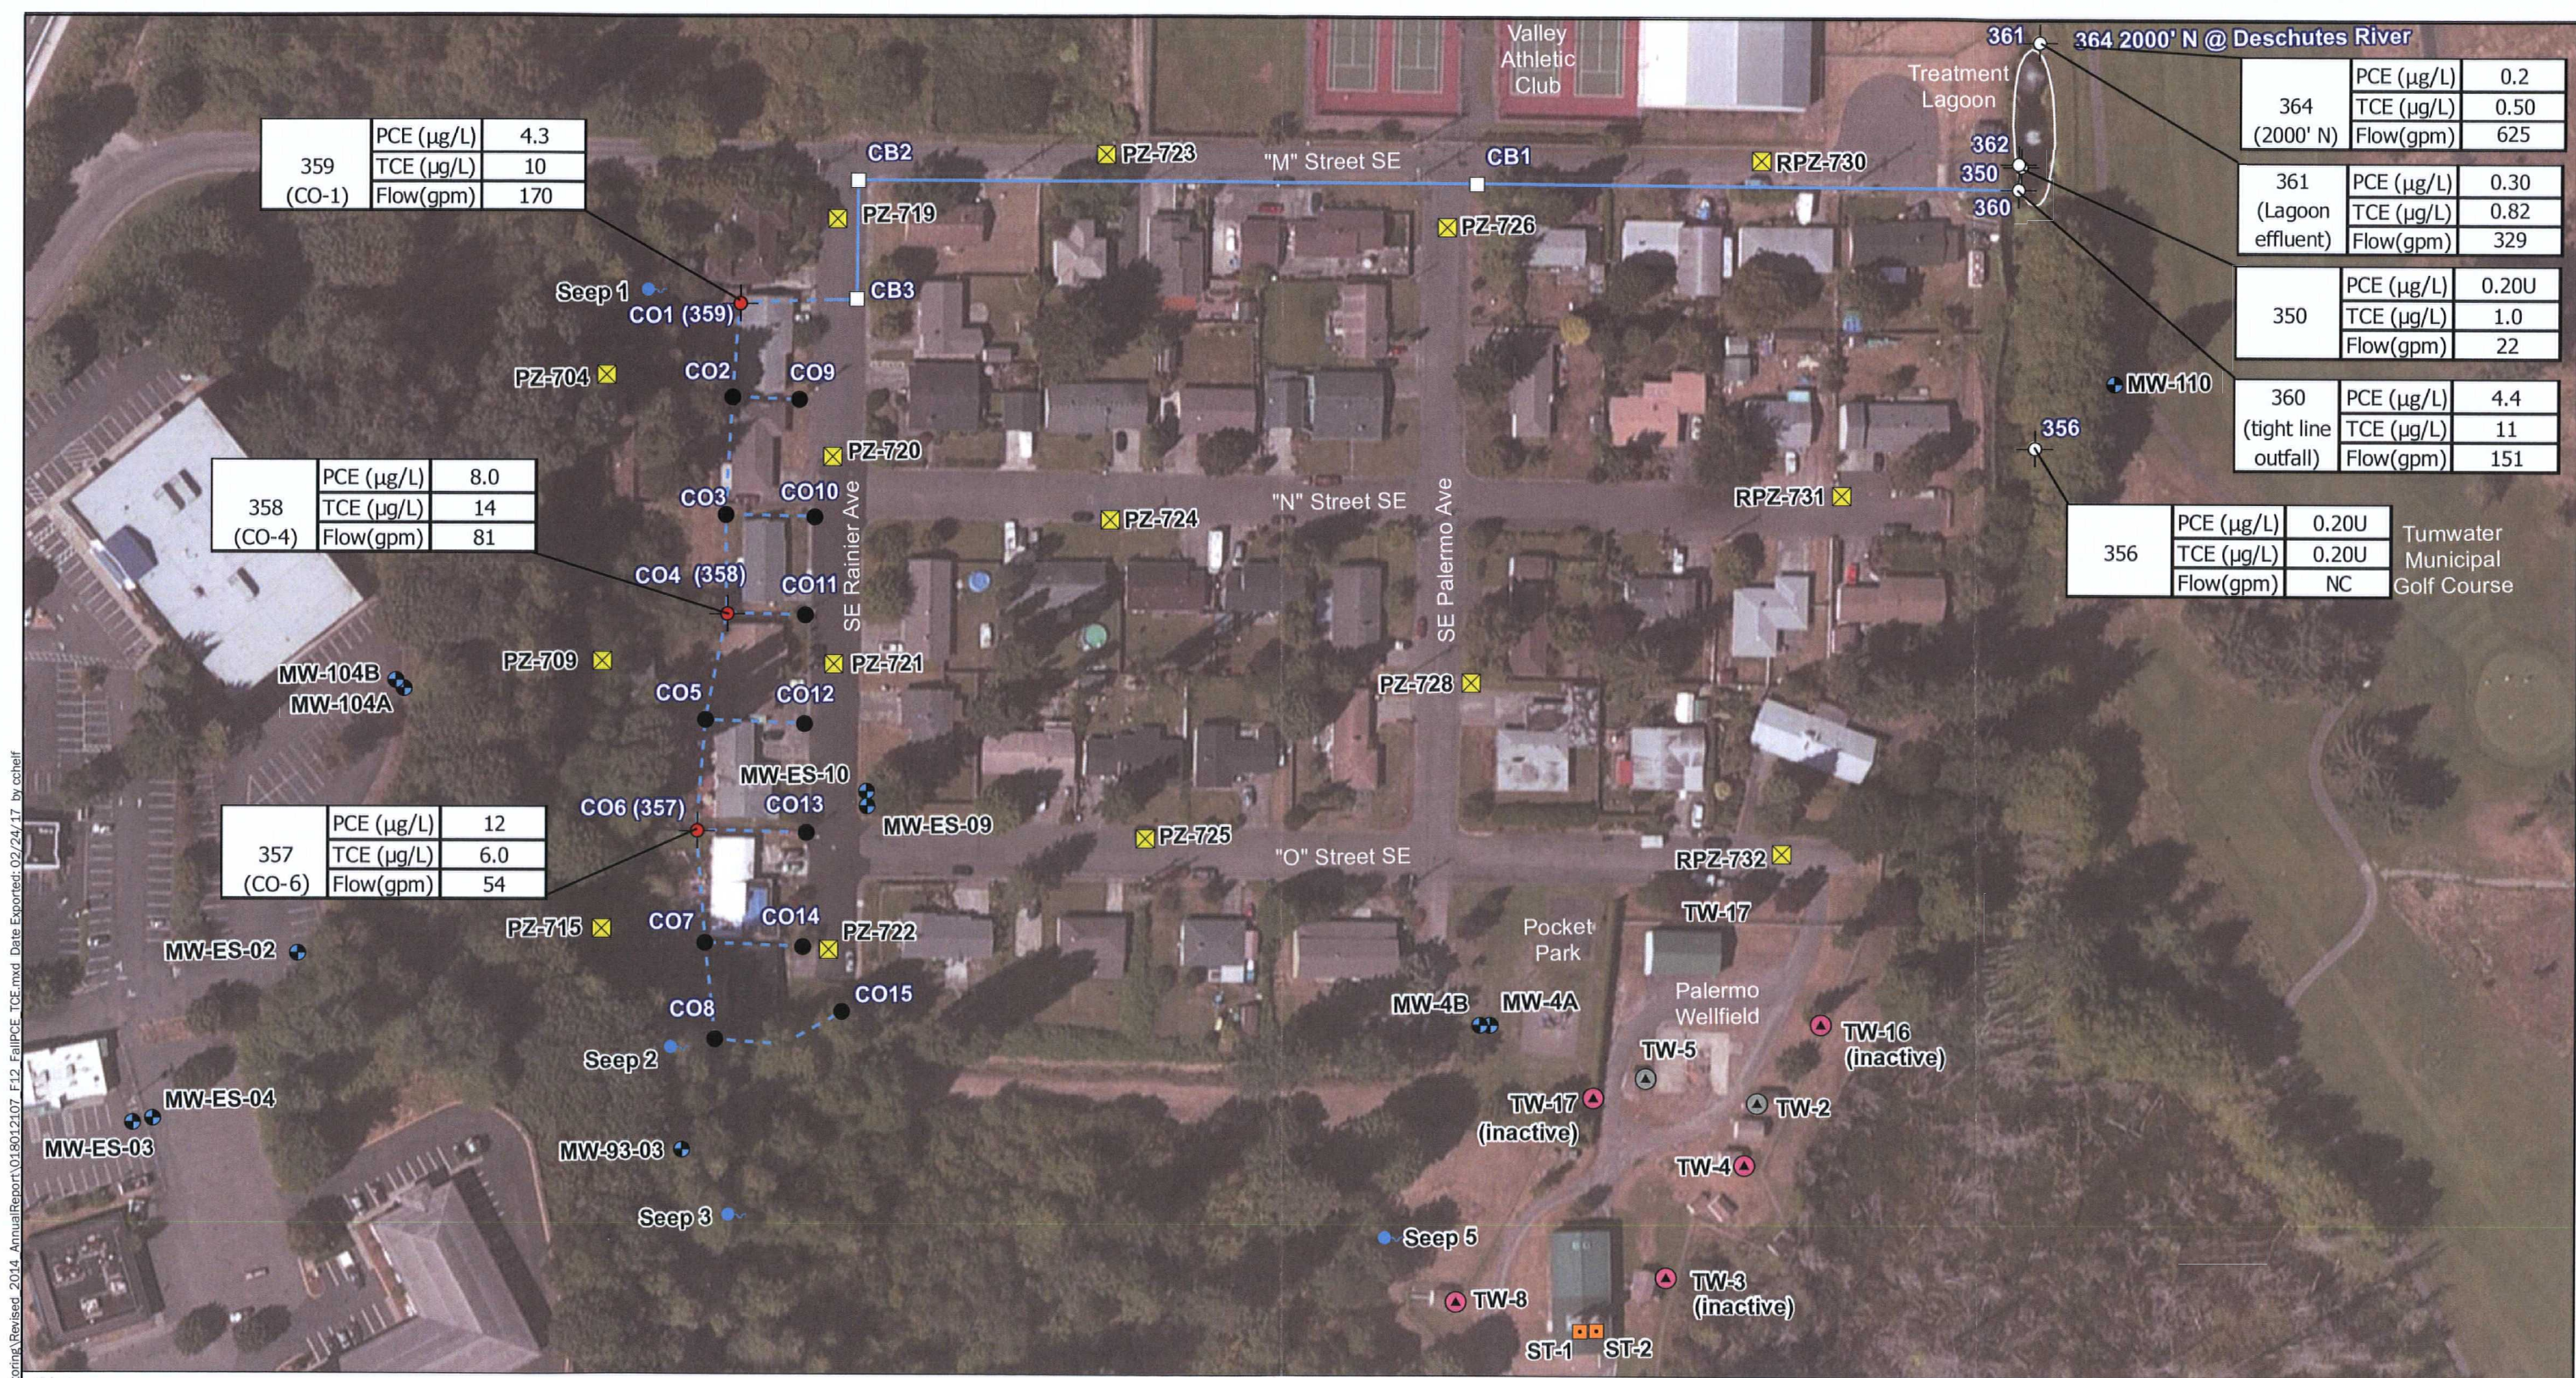
359 (CO-1)	PCE (µg/L)	4.3
	TCE (µg/L)	10
	Flow(gpm)	170

358 (CO-4)	PCE (µg/L)	8.0
	TCE (µg/L)	14
	Flow(gpm)	81

PCE and TCE concentrations continue to be the highest in groundwater from Stations 357 (CO-6), 358 (CO-4), 359 (CO-1) and 360 (Figures 11 and 12). The highest concentrations of PCE in water samples collected from the subdrain during Spring 2014 were measured at Station 357 (CO-6) and the highest for TCE during the same period was at Station 358 (CO-4). Similar conditions were encountered during the Summer 2014 monitoring.
